Product Alert

PGR Technical Safety Bulletin

Subject: PGR - Perimeter Guard Rail Posts

IDENTIFICATION CHART: PERIMETER GUARD RAIL POST (PGR)

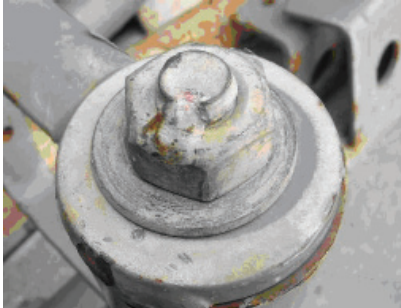
Photo 1

PGR's having fillet welds not welded completely around the threaded rod as shown in Photo 1. See Identification Chart.

3.1 Items not in use should be returned to Safway per the PGR Exchange Procedures enclosed.

3.3 Caution must be taken when removing the PGR. To ensure the nut does not come off the threaded rod when dismantling, use a box end or open end wrench. Take care to avoid turning the nut off the threaded rod to prevent the inner tube from falling to the ground, which could cause **serious injury, death, and/or property damage.**

Upon dismantling, set aside PGR for identification and possible rework. See Identification Chart.

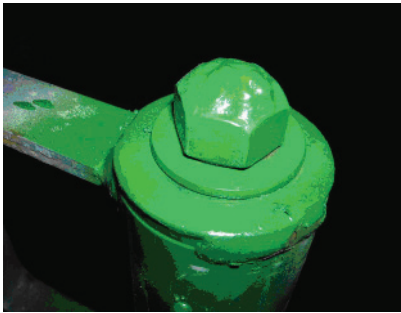
Photo 2

- **Weld completely around the threaded rod, the top portion of the PGR painted green. See Photo #2.**

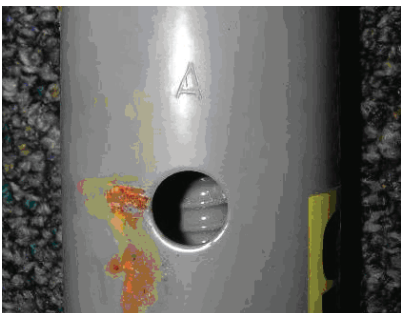
Photo 3

- **The letter "A" stamped above the lubrication hole. See Photo #3.**

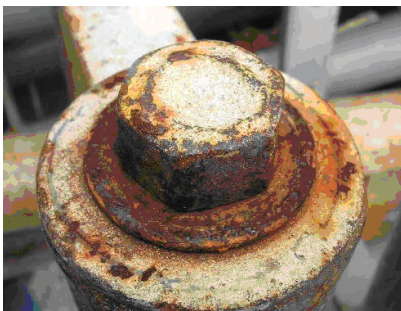
Photo 4

4.2 PGR's with top nut plug welded. See Photo #4.

PGR's that were plug welded, no portion of the weld is visible above the nut. See PGR Identification Chart.

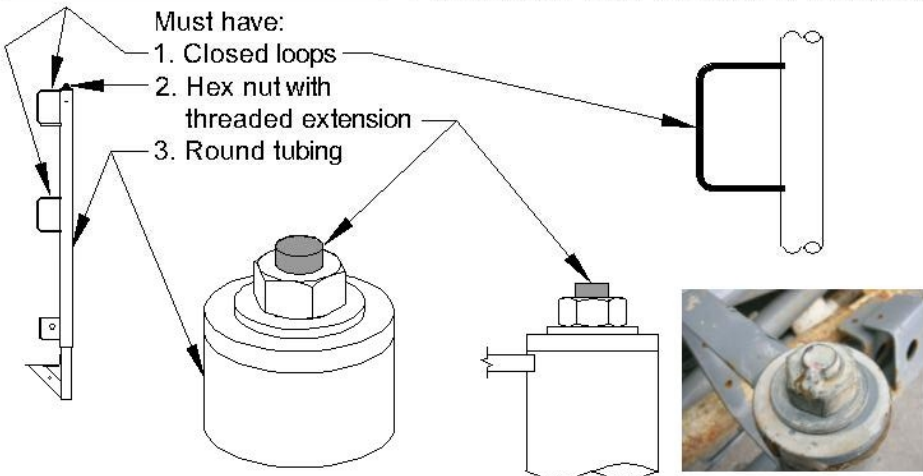
<p>THYSSENKRUPP SAFWAY PGR Post MUST look EXACTLY like this.</p> <p>Must have:</p> <ol style="list-style-type: none"> 1. Closed loops 2. Hex nut with threaded extension 3. Round tubing

<p>ISOLATE REWORK REQUIRED</p>
	<p>THYSSENKRUPP SAFWAY PGR Example of post NOT part of recall.</p> <p>Must have:</p> <ol style="list-style-type: none"> 1. Closed loops 2. Green paint 3. "A" stamp 4. Round tubing

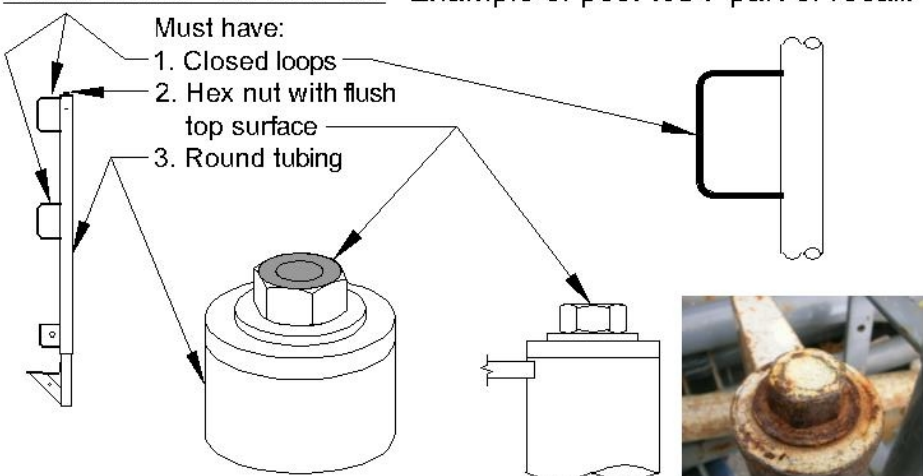
<p>NO ACTION REQUIRED</p> <p>REWORKED AVAILABLE FOR RENTAL/SALE</p>
	<p>THYSSENKRUPP SAFWAY PGR Example of post NOT part of recall.</p> <p>Must have:</p> <ol style="list-style-type: none"> 1. Closed loops 2. Hex nut with flush top surface 3. Round tubing

<p>NO ACTION REQUIRED</p> <p>NOT AFFECTED AVAILABLE FOR RENTAL/SALE</p>
